Technical Note N-1284

ANALYSIS OF THE CONDITION OF ECHO TOWER,
AZORES FIXED ACOUSTIC RANGE, AFTER ONE
YEAR AT 1500 FEET OF DEPTH

May 1973

Naval Civil Engineering Laboratory
Port Hueneme, California 93043

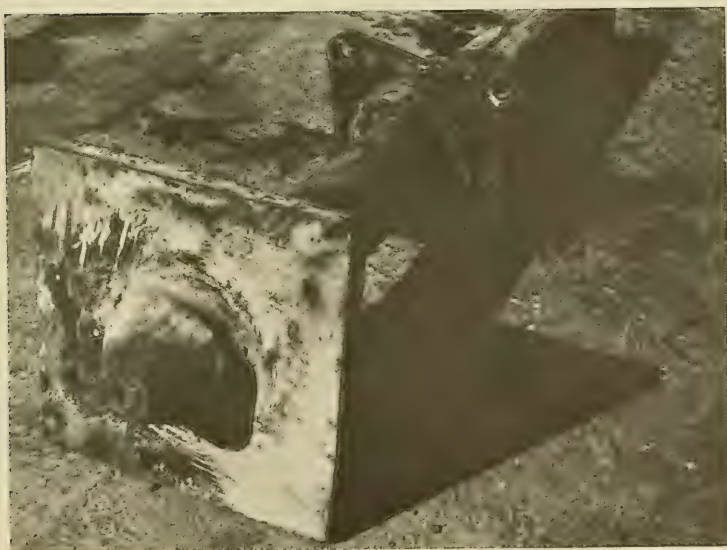
Figure 3. Shock Absorber.

The shock absorbers, as shown in Figure 3, were covered with loose, flaky red rust and rust stains. The surfaces under the rust were etched but no pitting was noted. The area under the missing hardened tip was as corroded as the adjacent areas on the cone, which indicates that the hardened tips were lost during emplacement. Areas under the undamaged paint coating were unattacked. The paint coatings showed no undercutting adjacent to damaged areas.

Echo tower was to be reemplaced if its condition permitted. As the damage resulting from emplacement and retrieval was minimal and the amount of corrosion found did not preclude reemplacement, the tower was repaired. The four shock absorbers were replaced with similar units. However, the tips on these units were screwed into place in contrast to the pressed-in units originally used. These screwed-in tips were further secured by welding and are shown in Figure 17. The universal joint was relubricated. The tower base, universal joint, main column and buoyancy sphere were cleaned by an air powered high pressure water jet and recoated with a copper oxide-pigmented rubber-based antifouling topcoat. The yellow enamel identifying marks were reapplied after the antifouling coat had cured. The condition of the buoyancy sphere after repair is shown in Figure 18. The fasteners used to secure the cable conduit to the main column were recoated as required with a rubber based sealing compound. Rusted areas on the steering carriage and antenna support arms were cleaned and recoated with a two coat, polyamide-cured epoxy paint system. The gas generators were replaced. The attacked areas on the antennas were carefully sanded and cleaned before recoating with the same paint system. The gas connections between the ends of the compliant tubes and the gas manifolds were cleaned, the clamps and tubing replaced as necessary and recoated with a two component sealing compound where any rust staining of the connections was noted. Areas of paint failure on the foam tower were repaired using the topcoat of the polyamide cured epoxy paint system. Identifying marks were reapplied to the foam tower. The recoated foam tower is shown in Figure 19. The main lifting eye was cleaned, and then recoated with the two coat polyamide cured epoxy system. The tower was then considered to be ready for reemplacement.

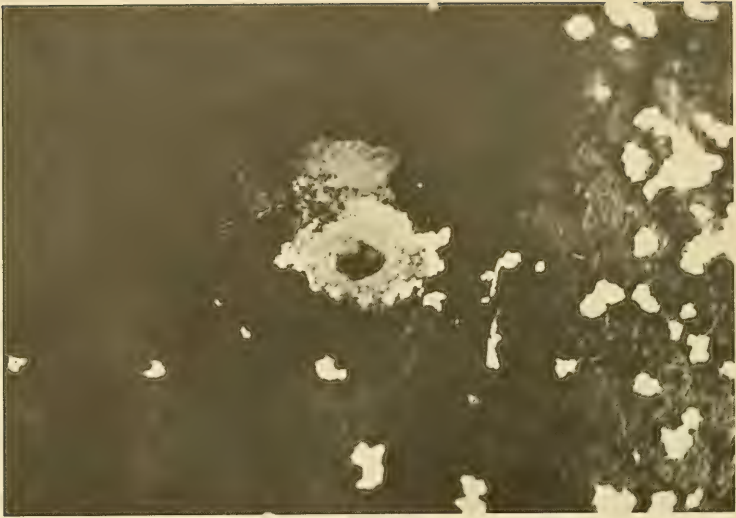
Figure 4. Pit on upper portion of buoyancy sphere.

About 10% of the sphere was covered with blisters before rinsing. About half of these blisters ruptured upon rinsing and exposed the underlying primer. The rust at the areas of paint failures noted in the previous inspections was now loose and flaky. The pit noted in the first inspection (as shown in Figure 4) was accurately measured and found to be a maximum of 0.110" deep. No other significant corrosion was noted. The coating on the joint between the sphere and the steering carriage was blistered and these blisters ruptured upon being rinsed. No corrosion under the ruptured blisters was noted. The rust staining at the faying surfaces of the joint remained after rinsing. The coating on the steering carriage was now moderately blistered as shown in Figure 5. However, no rust staining of the primer underneath these blisters was noted when the blisters ruptured upon rinsing. The rusting at the carriage stop housing flanges was now loose and flaky. Loose flaky rust around one fastener on the flange was noted and is shown in Figure 6. The altitude indicator, as shown in Figure 7, was readable even with the loss of a significant amount of paint coating. The aluminum alloy keys and jacks used to secure the steering carriage were covered with a thin superficial film of corrosion products, as shown in Figure 8. Attack of these areas was superficial and was essentially arrested after the tower was removed from the water.

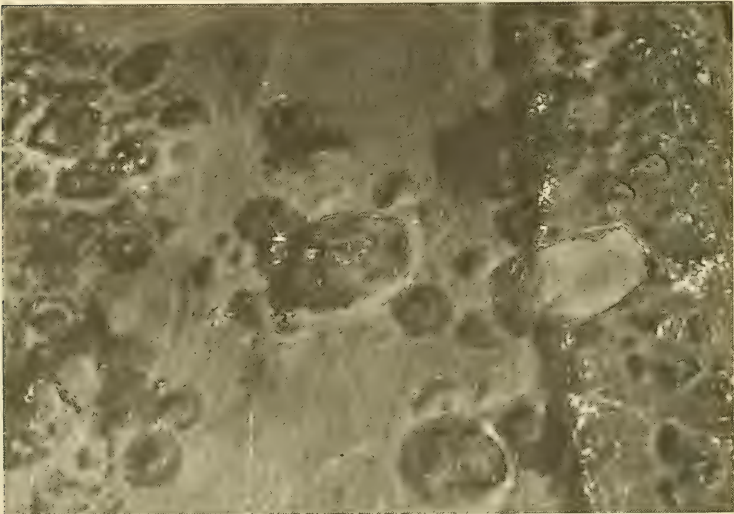
Figure 5. Blisters on steering carriage.

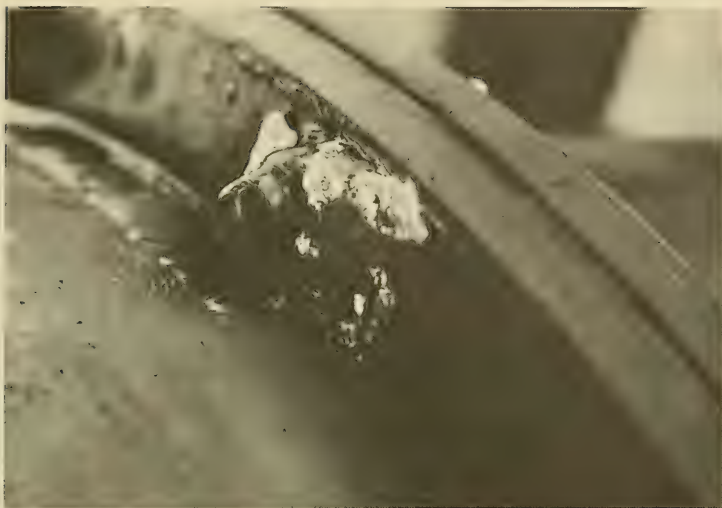
Figure 6. Fastener on carriage stop housing flange.

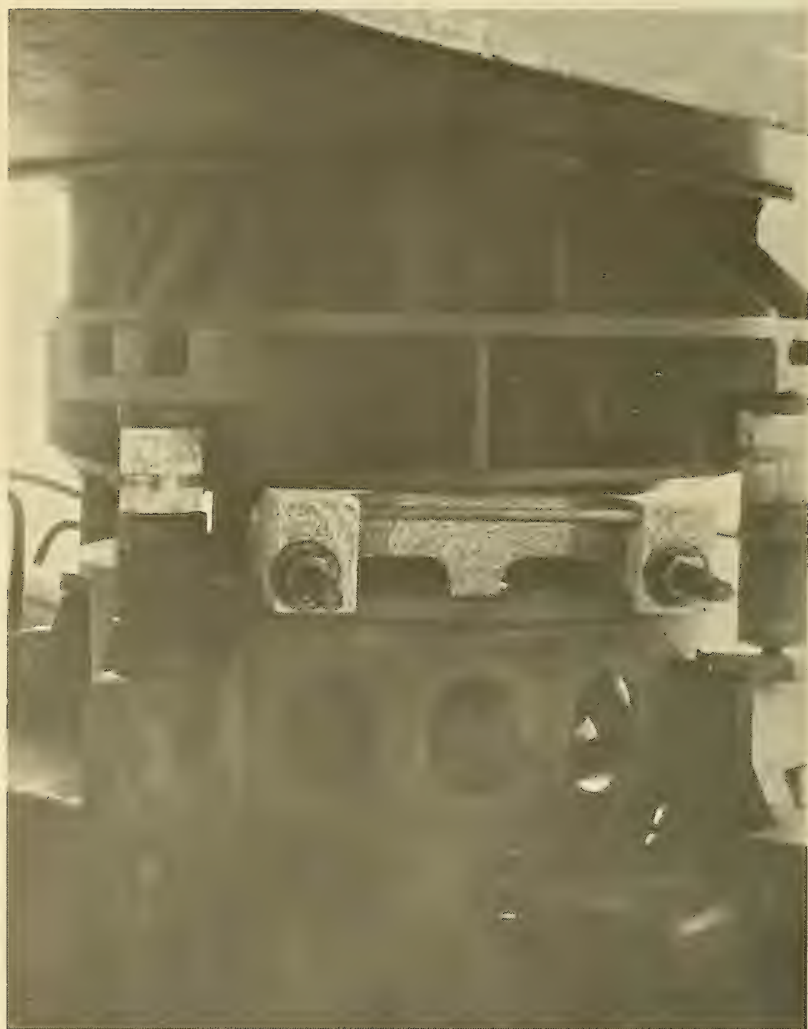
Figure 8. Carriage lock keys and jacks.

Aluminum alloy keys and jacks were attached to the steering carriage after recovery in order to secure the antennas during the tow. After five days exposure these keys and jacks were covered with a rather thick coating of corrosion products. This attack was due to galvanic corrosion between the keys and jacks and the exposed steel areas on the tower.

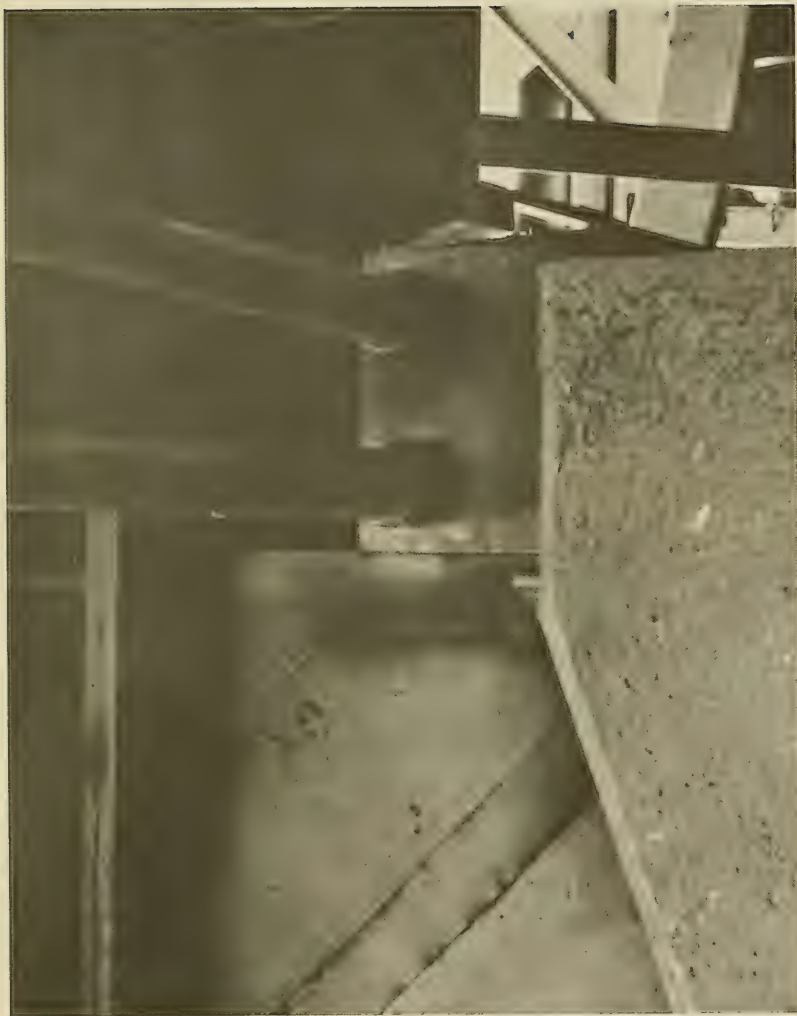
Figure 9. Gas generator support structure.

The gas generator support structure, as shown in Figure 9, had loose flaky red rust at the edges of the metal frame members. Only superficial corrosion was found associated with this rusting. The titanium cathode on the electrolytic generator, as shown in Figure 10, was unattacked. The platinum anode was also unattacked. The remaining fouling on the platinum anode was easily removed by fresh water rinsing.

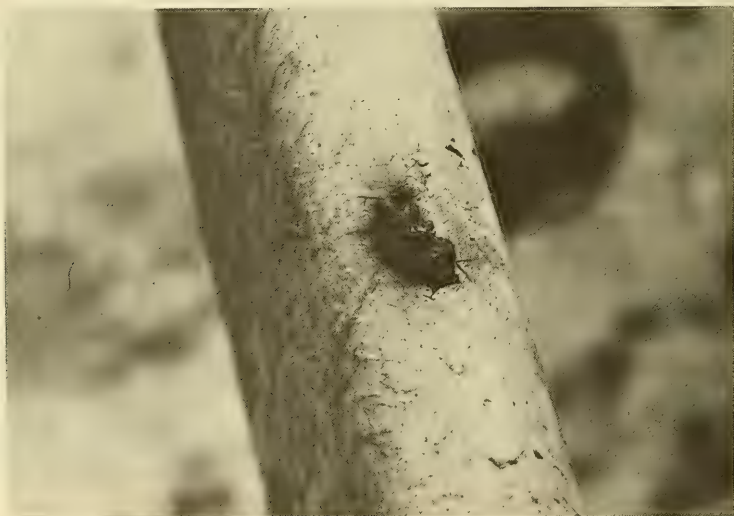
Figure 11. Rusted area of middle frequency antenna.

Figures 11 through 14 show the results of inspection of a typical rusted area on the middle frequency antenna. Figure 11 shows the area covered with a loose flaky red rust deposit. Figure 12 shows the area after removal of the deposit. Figure 13 shows the defects in the coating which resulted in the attack. Figure 14 shows the area after removing the coating. Note the feathered edge of the coating in Figure 14. Only three coats of paint are present. A red primer, white second coat and gray topcoat. No zinc rich primer was used on this or any other rusted areas of the compliant tubes. Brushmarks in the coatings at the rusted areas indicated that the coatings had been "touched up" at these locations without using the zinc rich primer. Removal of the upper coats of paint in an unattacked area of the low frequency antenna showed that the zinc rich primer was present.

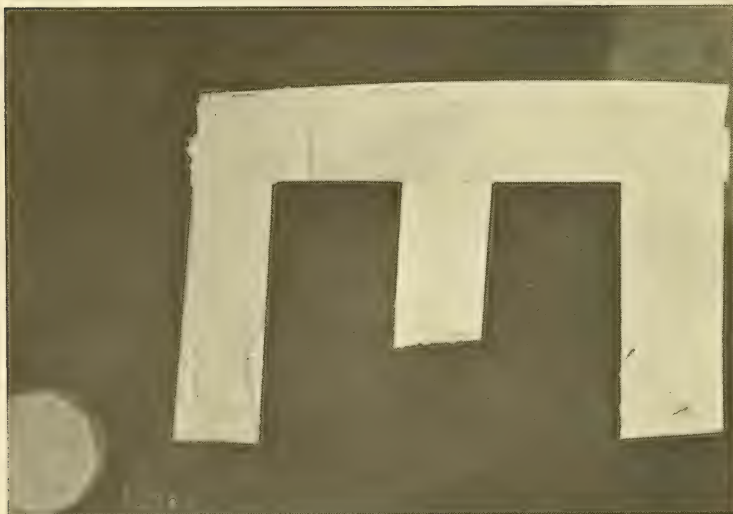
Figure 15. Portion of foam tower.

The condition of the syntactic foam blocks of the foam tower is illustrated in Figure 15. Although the coating at the identifying letter had failed, the underlying material was unattacked. No signs of water absorption or deformation of the foam blocks of the foam tower, low frequency antenna or gas generator support was noted. The main lifting eye at the top of the foam tower, as shown in Figure 16, was covered with a thin film of loose flaky red rust but no significant corrosion was noted underneath the rust layer.

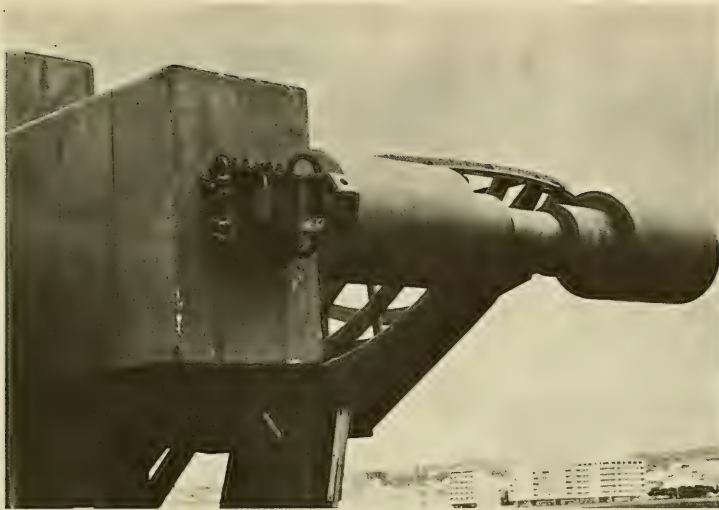
Figure 16. Main lifting eye at top of foam tower.
